Southern WV Safety Alert

U.S. Department of Labor
Mine Safety and Health Administration

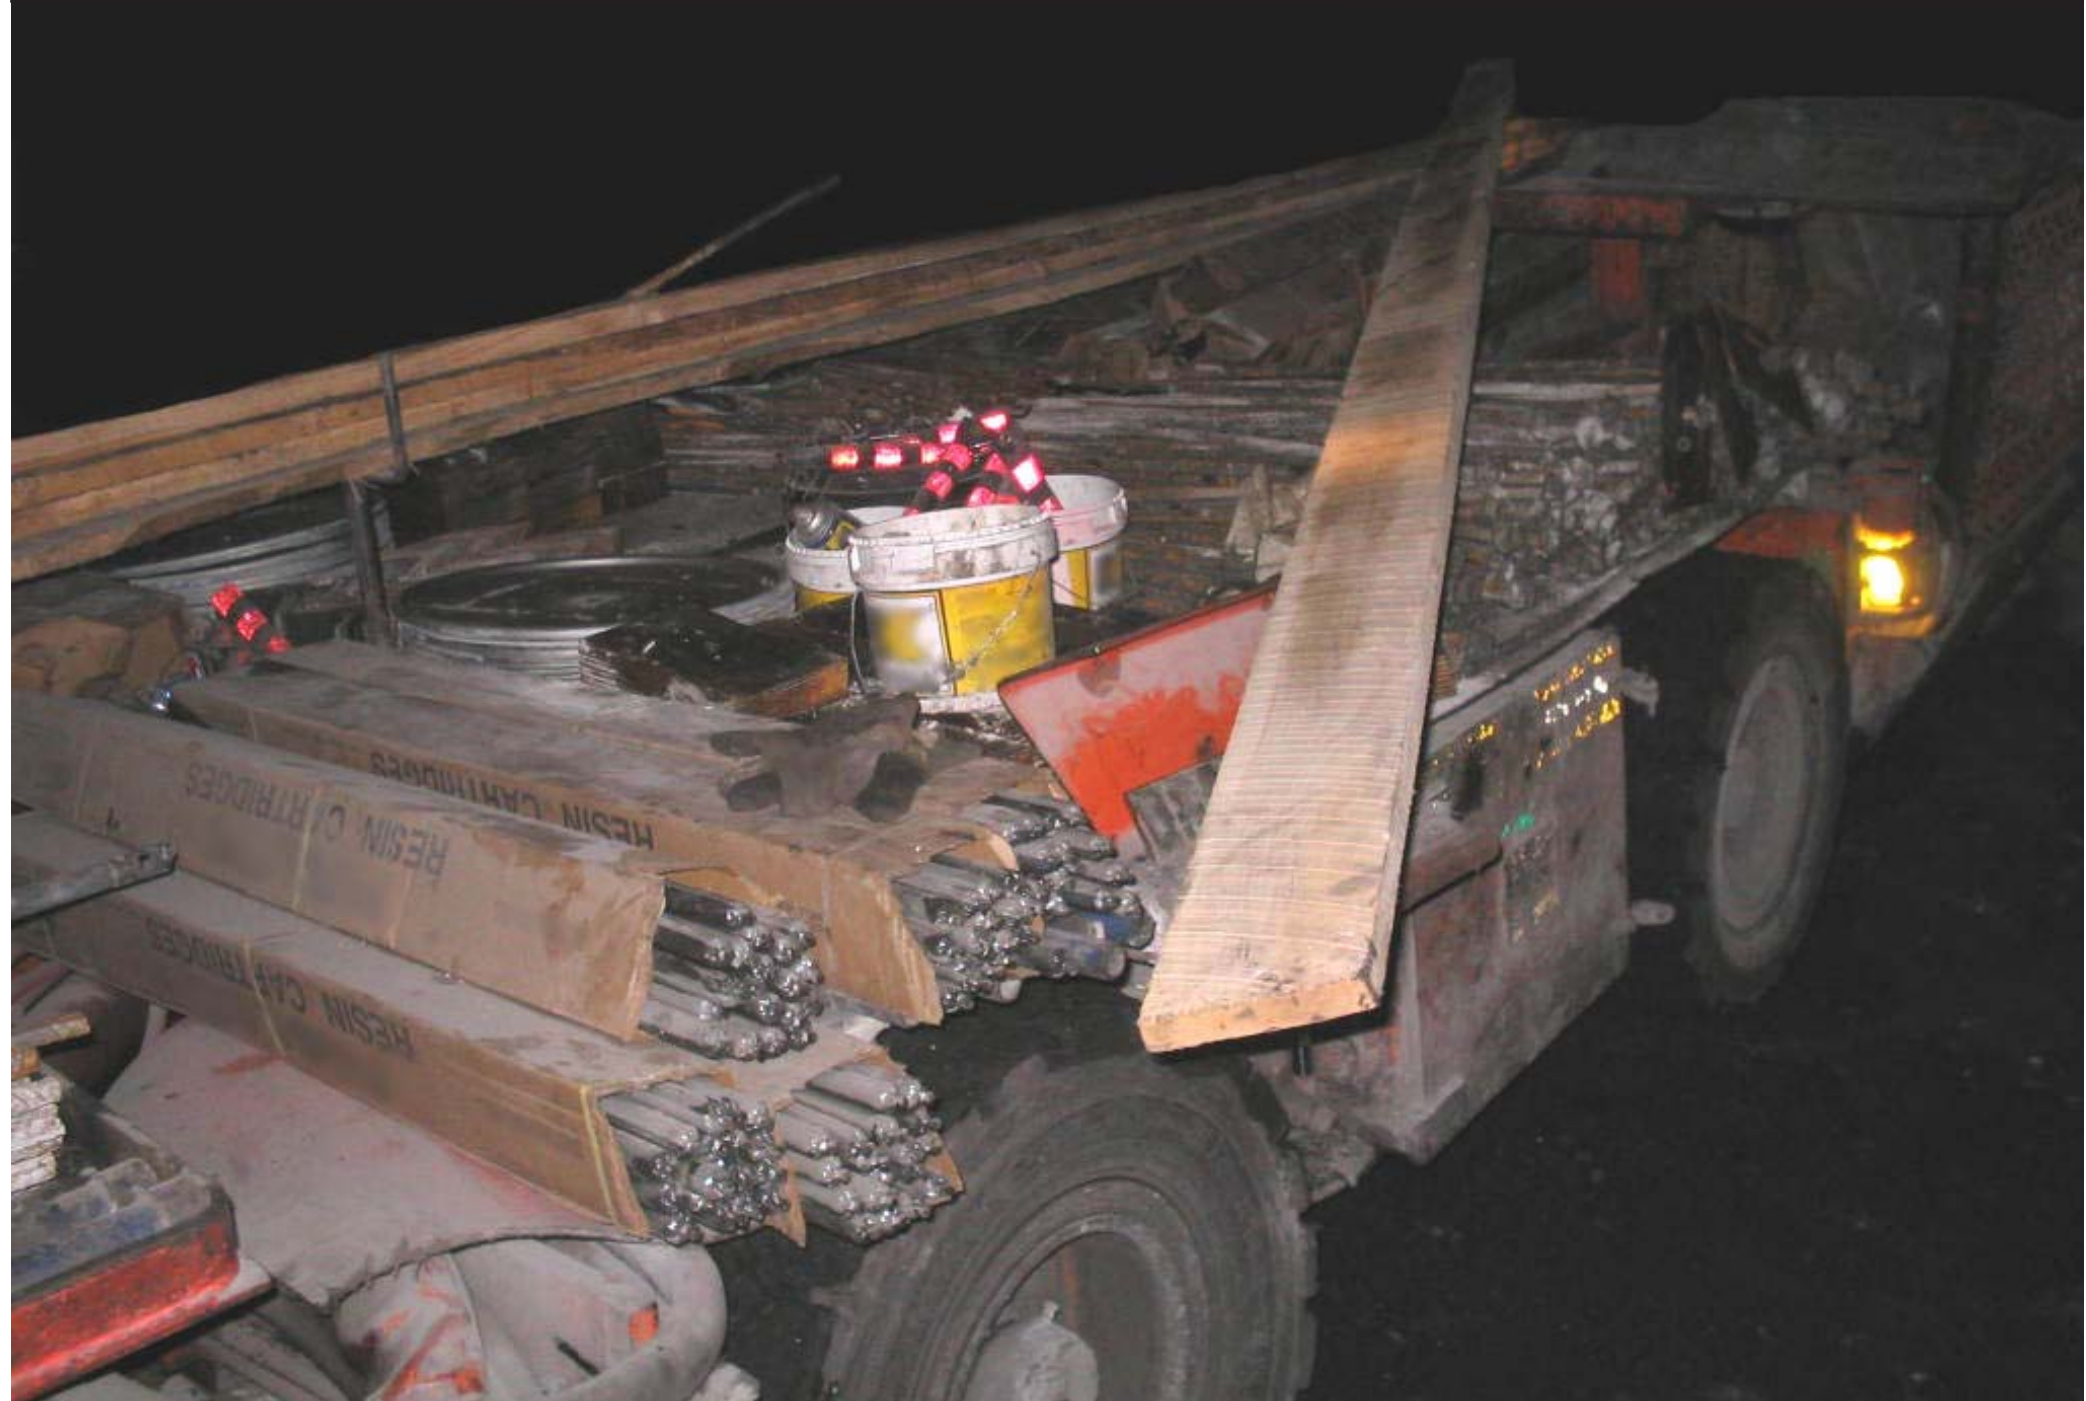
A roof bolting machine operator with 15 years mining experience was struck by a curtain board causing serious injury. The curtain board, lying on top of the roof bolting machine, came in contact with the outby corner of a coal pillar, causing the board to swing around and strike the victim. This accident occurred while the victim was tramming the roof bolting machine with the inch controls, turning the roof bolting machine from one entry into another.

- ✓ Boards and other large supplies must be secured by straps or other means to prevent hazards from shifting or falling.
- ✓ Supplies and other objects should not be allowed to overhang the deck storage area of a roof bolting machine.
- ✓ Inch-tram controls shall only be used when roof bolting. When conducting place changes the equipment operator must remain in the protective confines of the equipment cab.
